3 WEST OF US 83 NORTH

IDENTIFICATION	
(1) State Names	North Dakota
(8) Structure Number	0094-156.609
(5) Inventory Route	00094
(2) Highway Agency District	61
(3) County Code	Morton, North Dakota

(4) Place Code	7200
(6) Features Intersected	MISSOURI RIVER
(7) Facility Carried	INTERSTATE 94
(9) Location	3 WEST OF US 83 NORTH
(11) Mile Point	156.576 mi

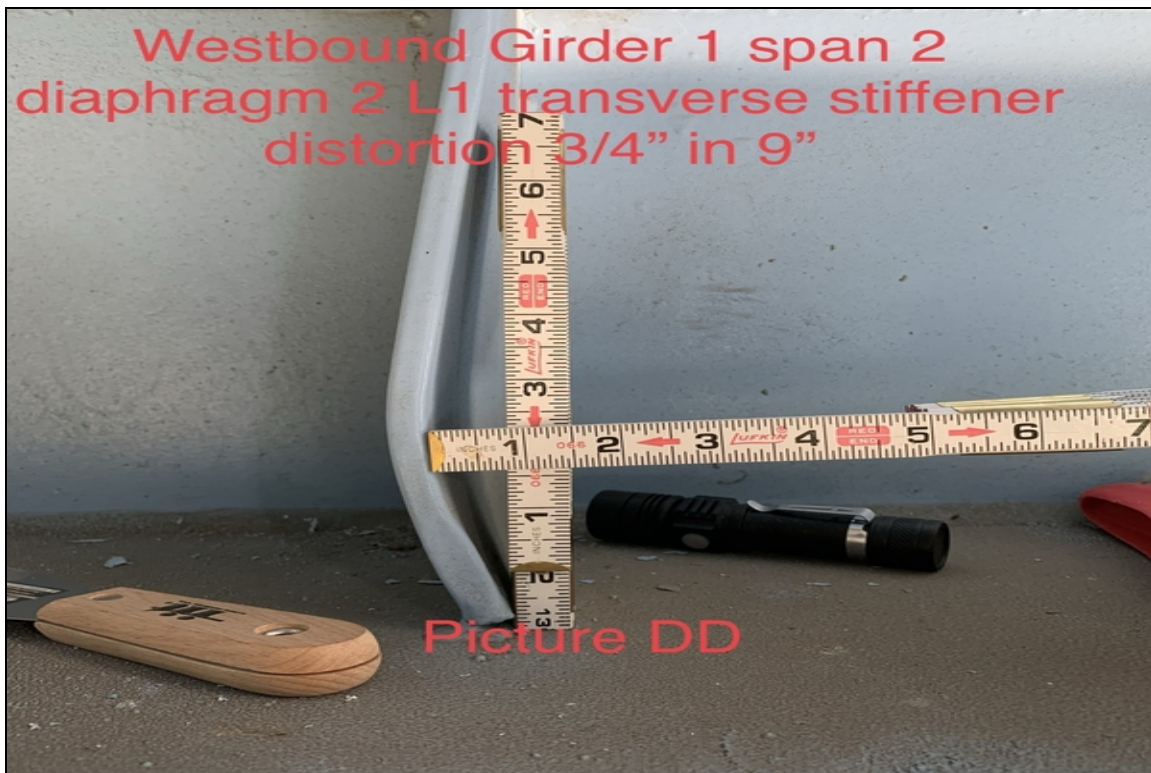
WB span 2 diaphragm 2 girder 1 L1 transverse stiffener distorting 3/4" in 9" (DD)

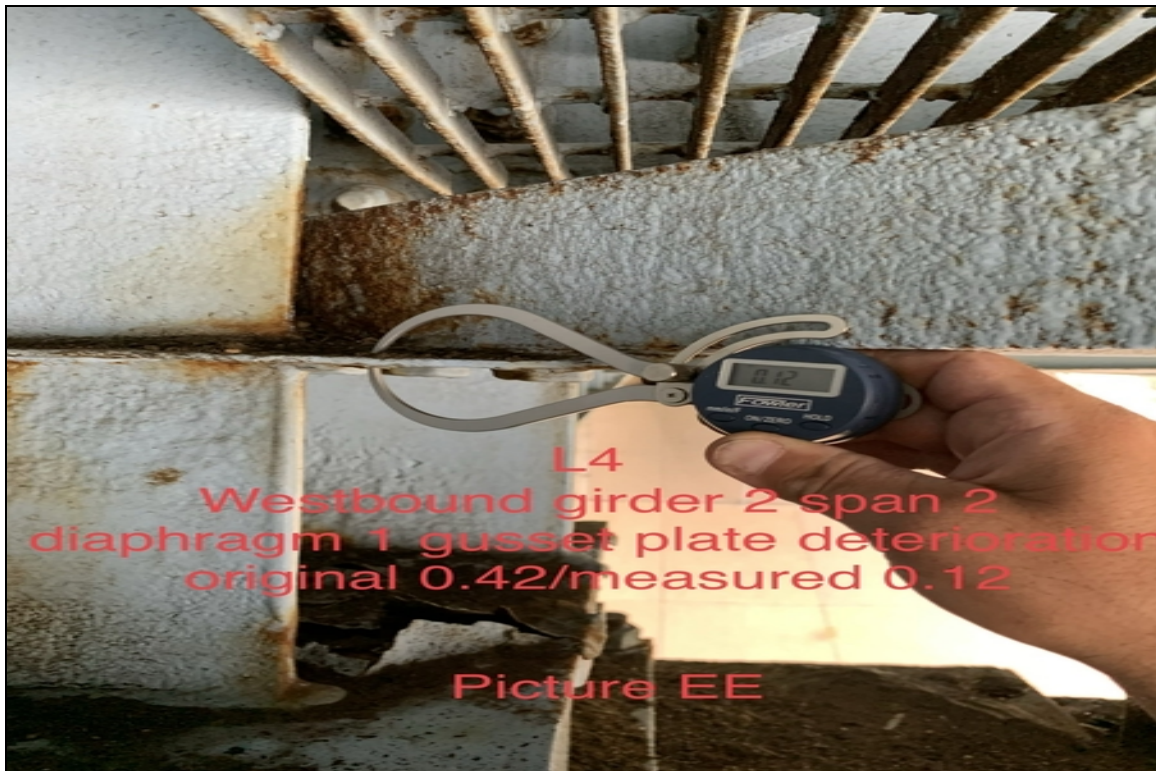
WB girder 2 span 2 diaphragm 1 gusset plate deterioration original 0.42" And measured 0.12" (EE)

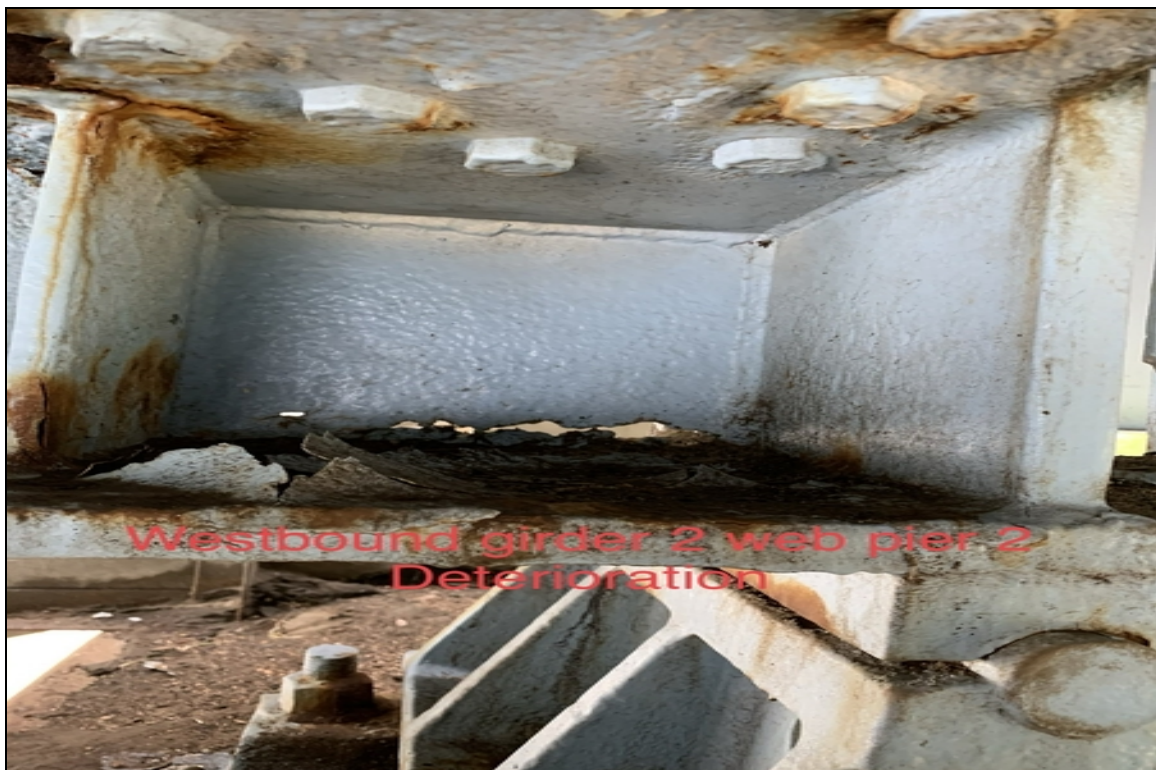
WB girder 2 weB pier 2 deterioration

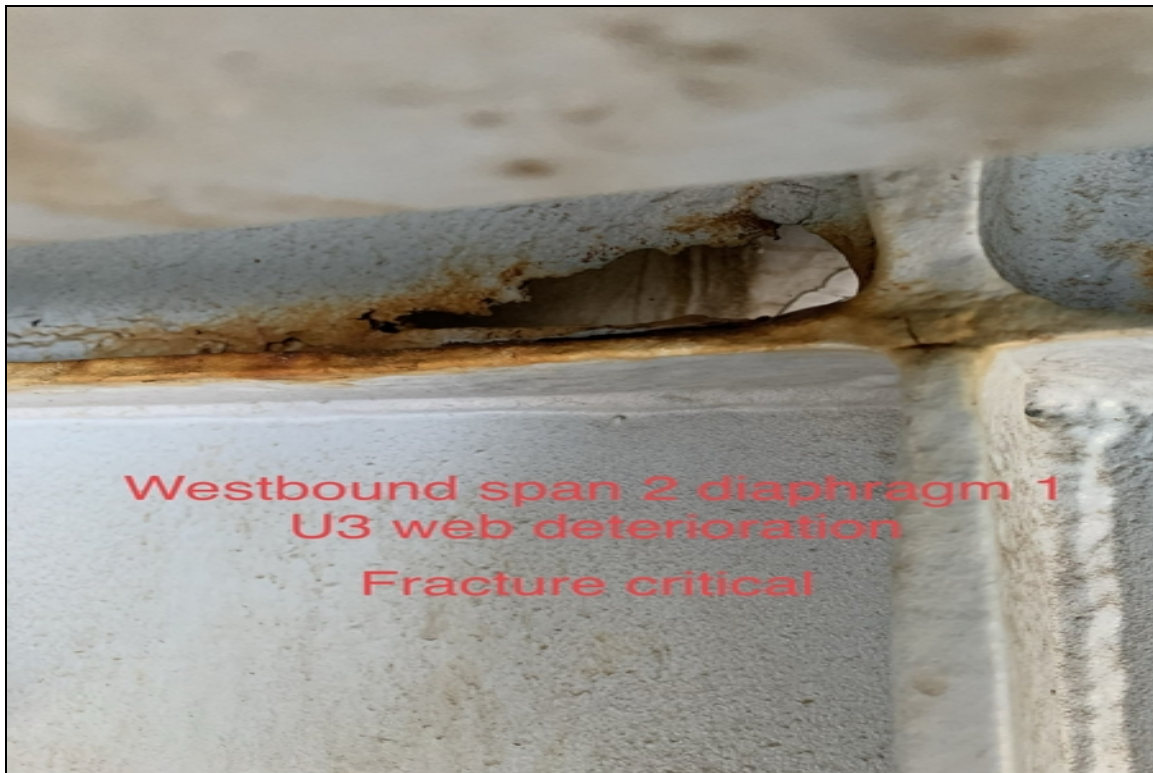
WB span 2 dia 1 U3 web deterioration fracture critical member

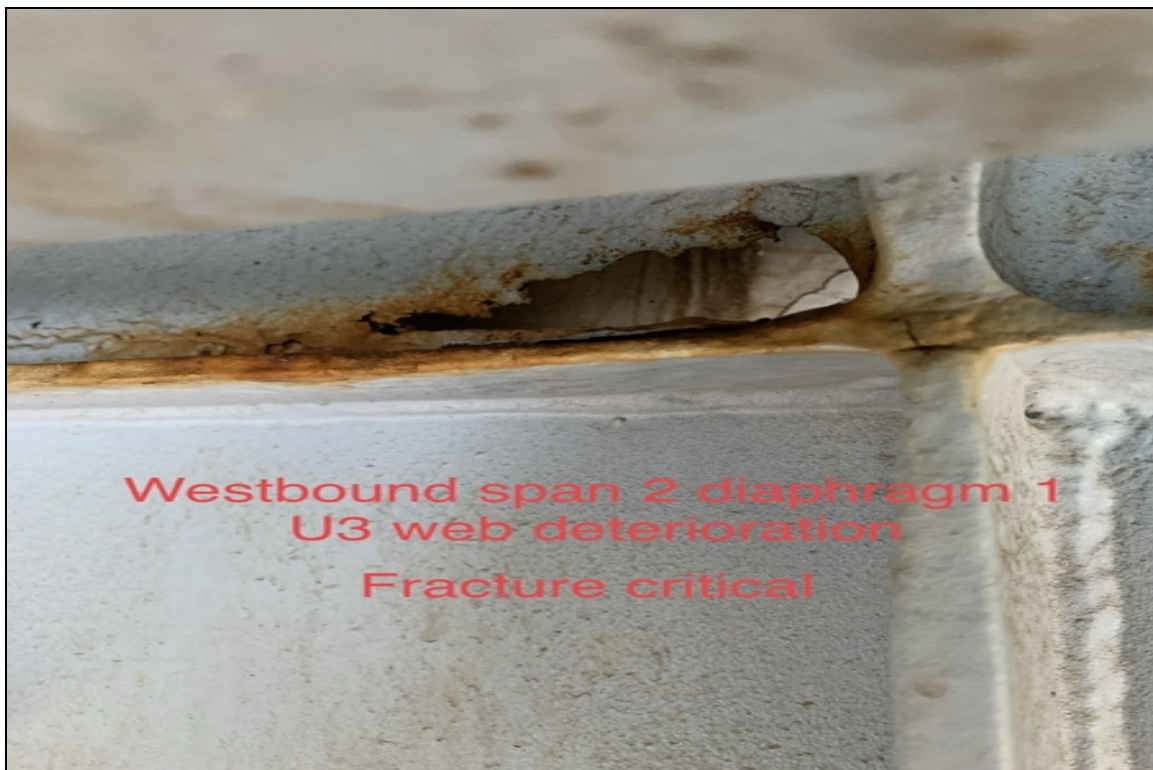
WB span 2 dia 1 U3 web deterioration fracture critical member

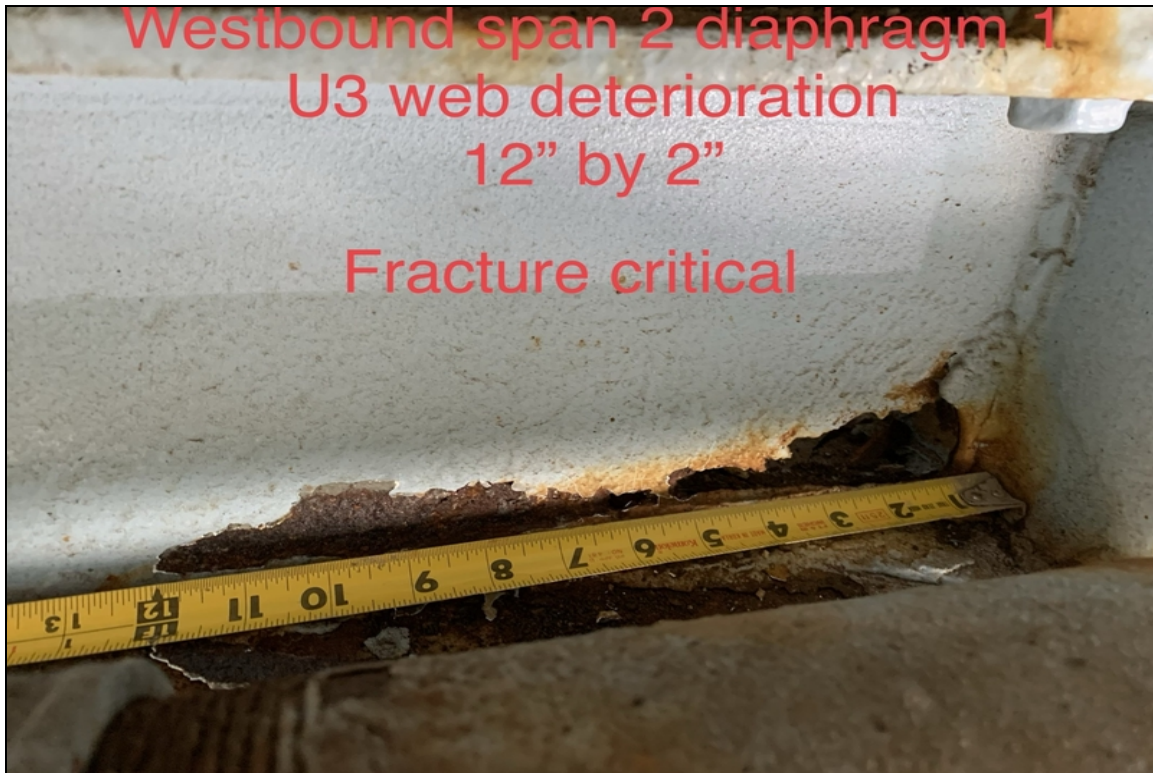
WB span 2 dia 1 U3 web deterioration 12"x2" fracture critical member

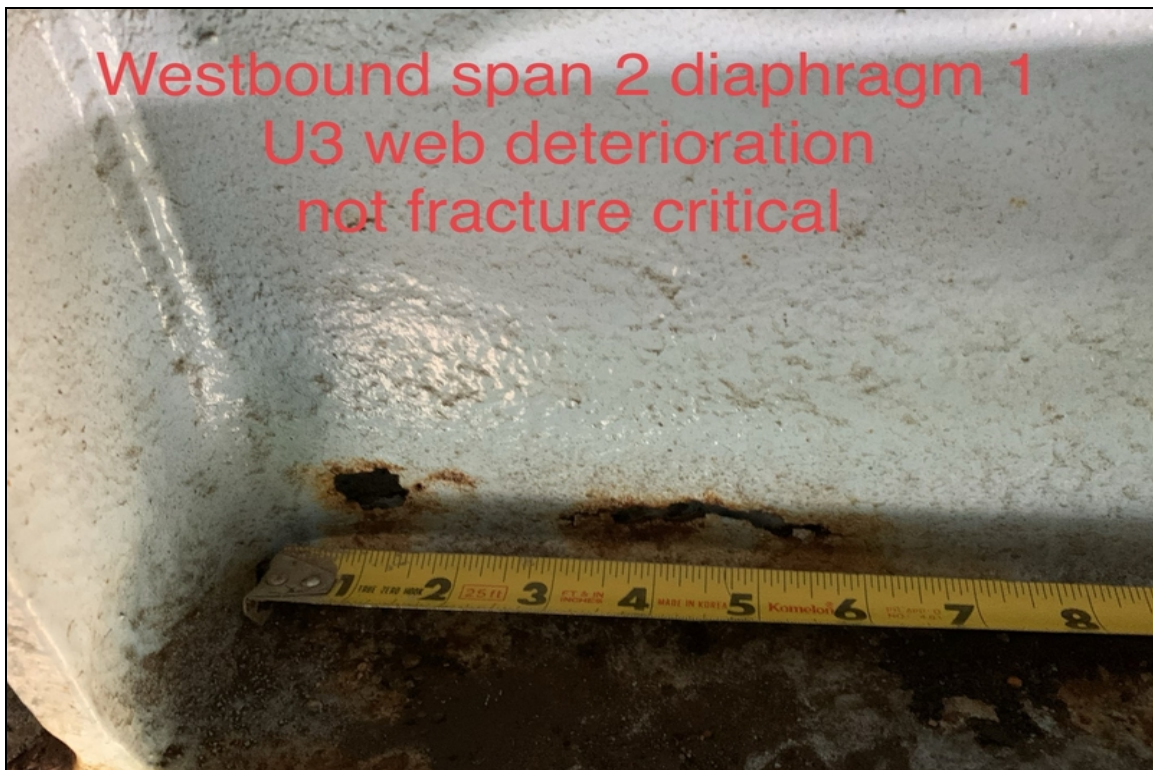
WB span 2 dia 1 u3 web deterioration not fracture critical member

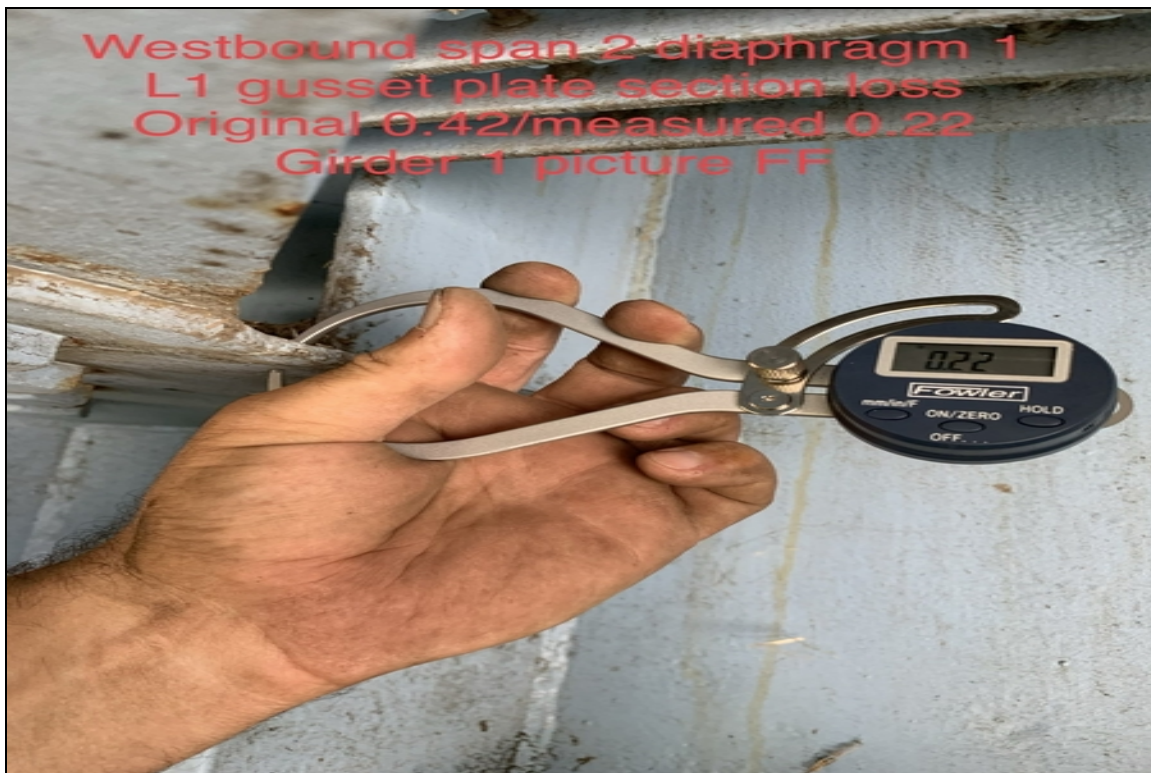
WB span 2 dia 1 L1 gusset plate section loss original 0.42/ measured 0.22 girder 1 (FF)

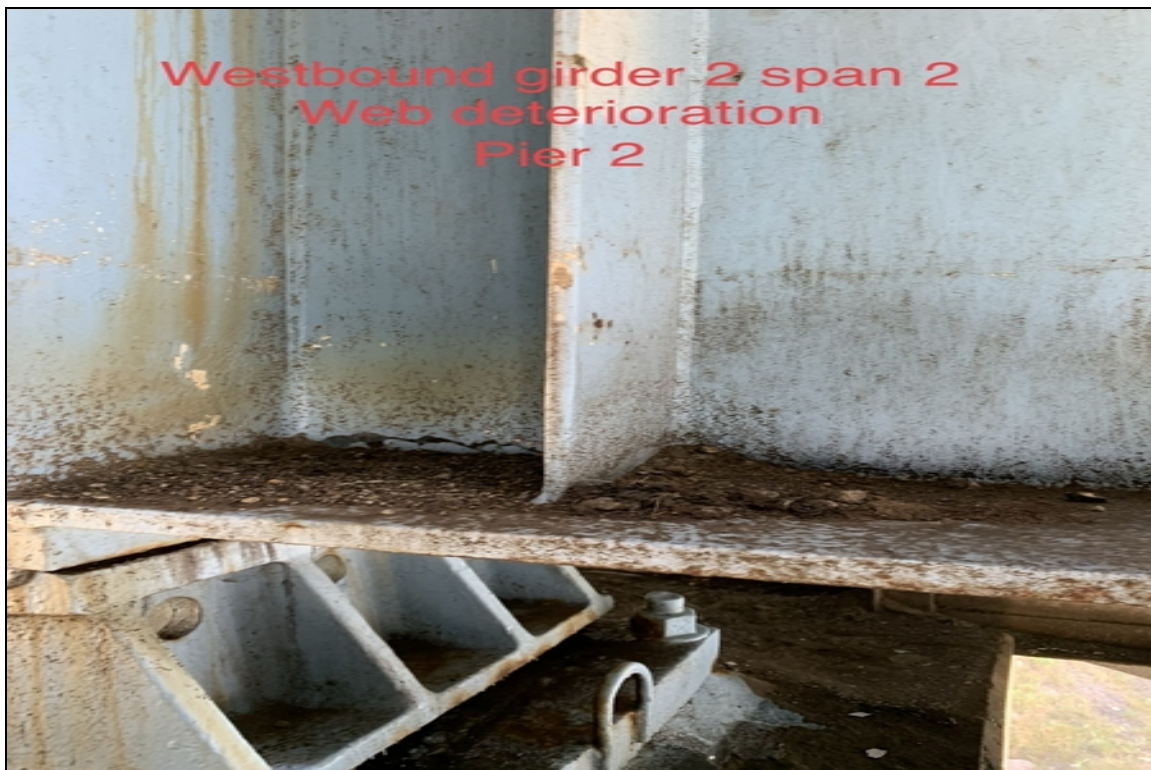
WB girder 2 span 2 Web deterioration pier 2

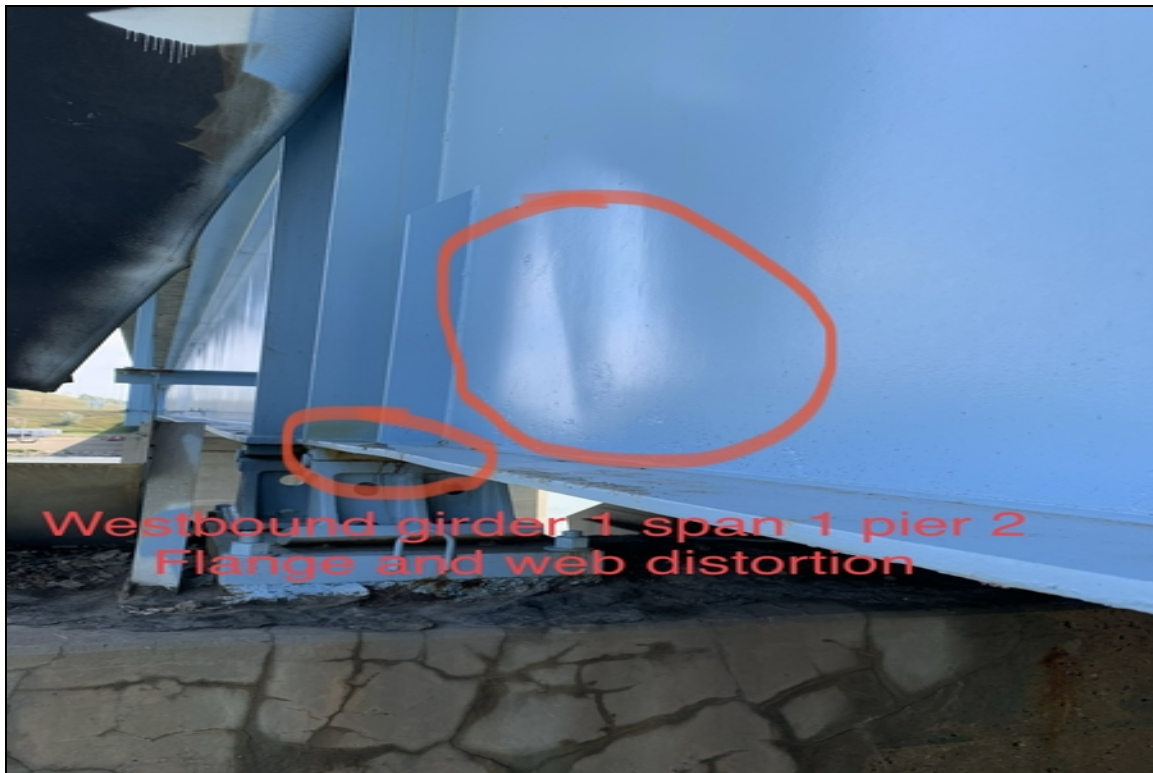
WB girder 1 span 1 Pier 2 Flange and web distortion

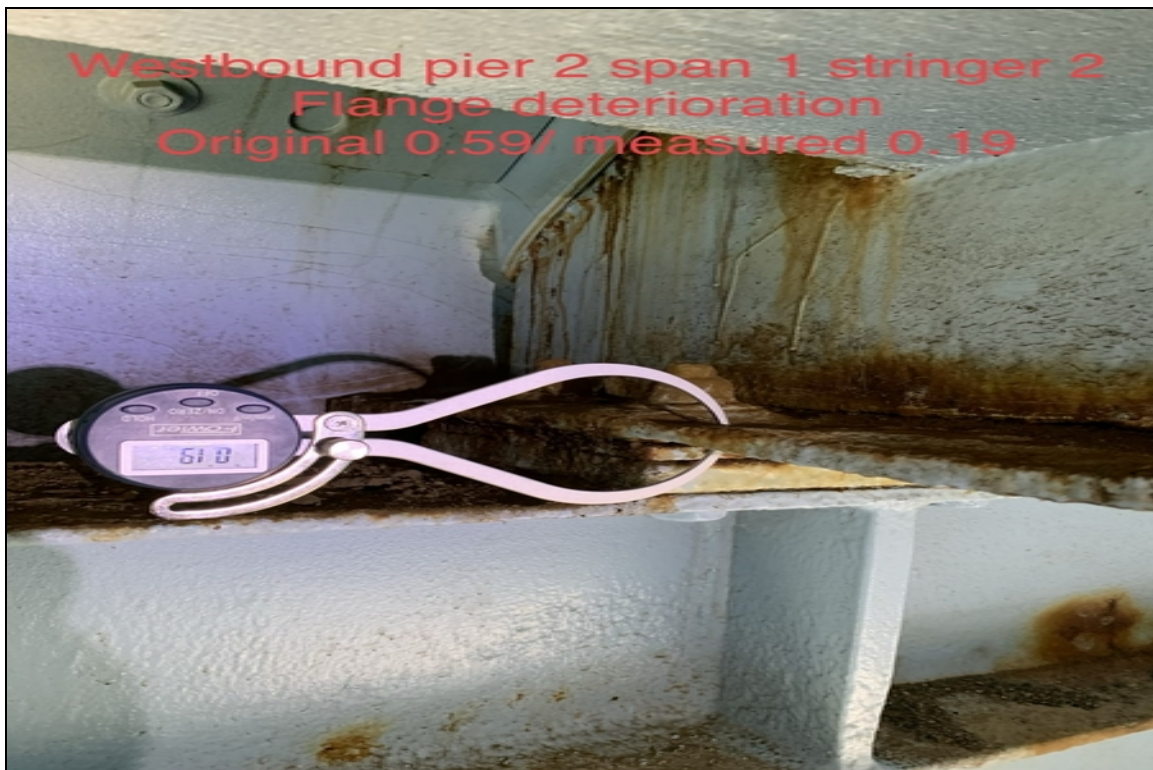
WB pier 2 span 1 stringer 2 flange deterioration original 0.59/ measured 0.19

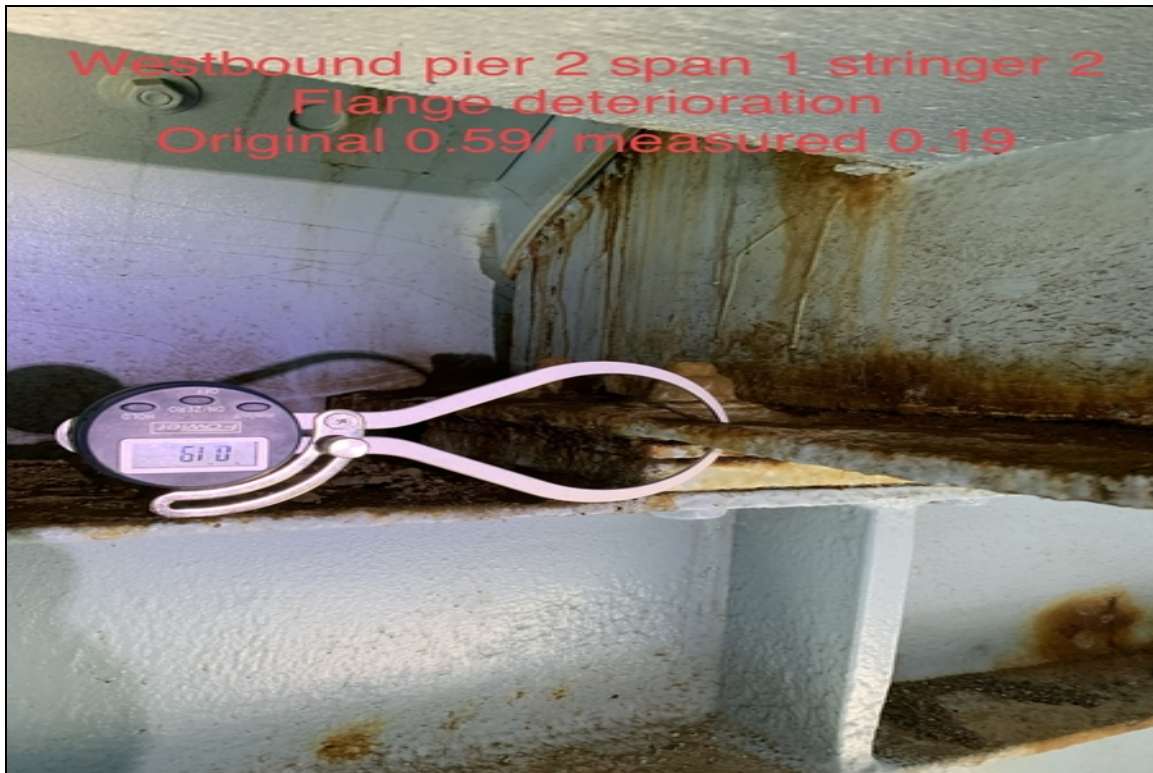
WB pier 2 span 1 stringer 2 flange deterioration original 0.59/ measured 0.19

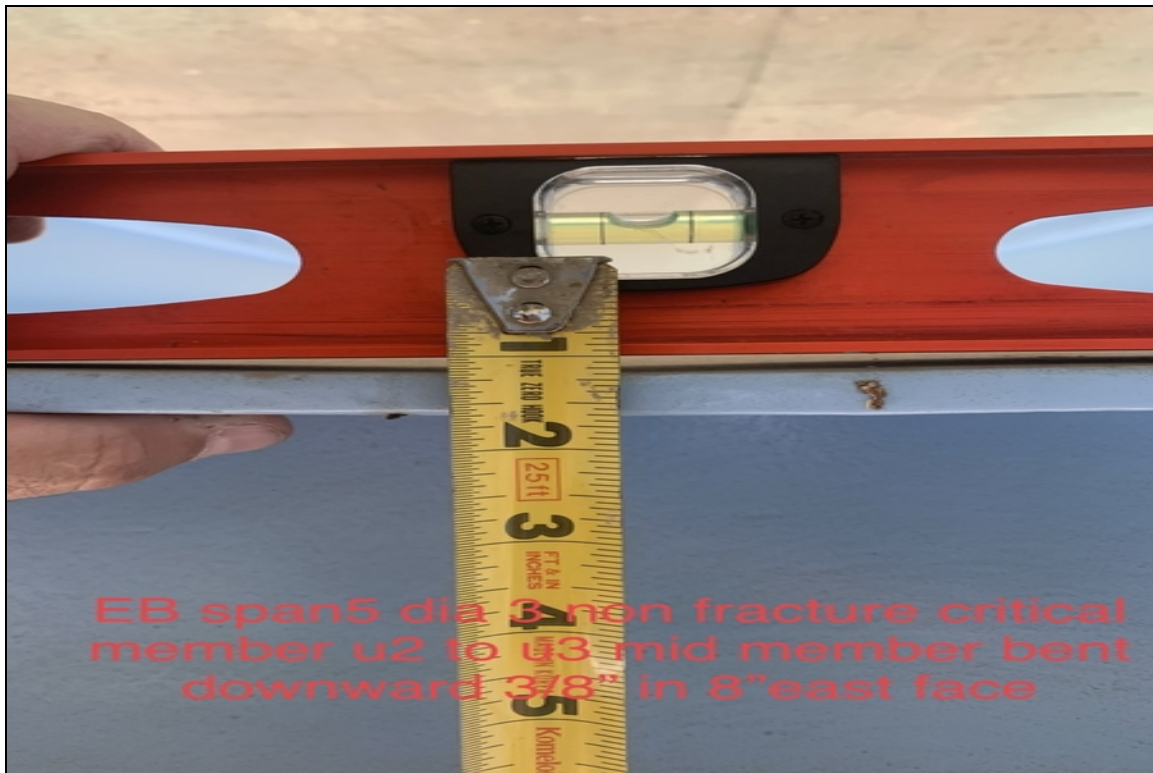
EB span 5 dia 3 non fracture critical member U2 to U3 mid member bent downward 3/8" in 8" east face

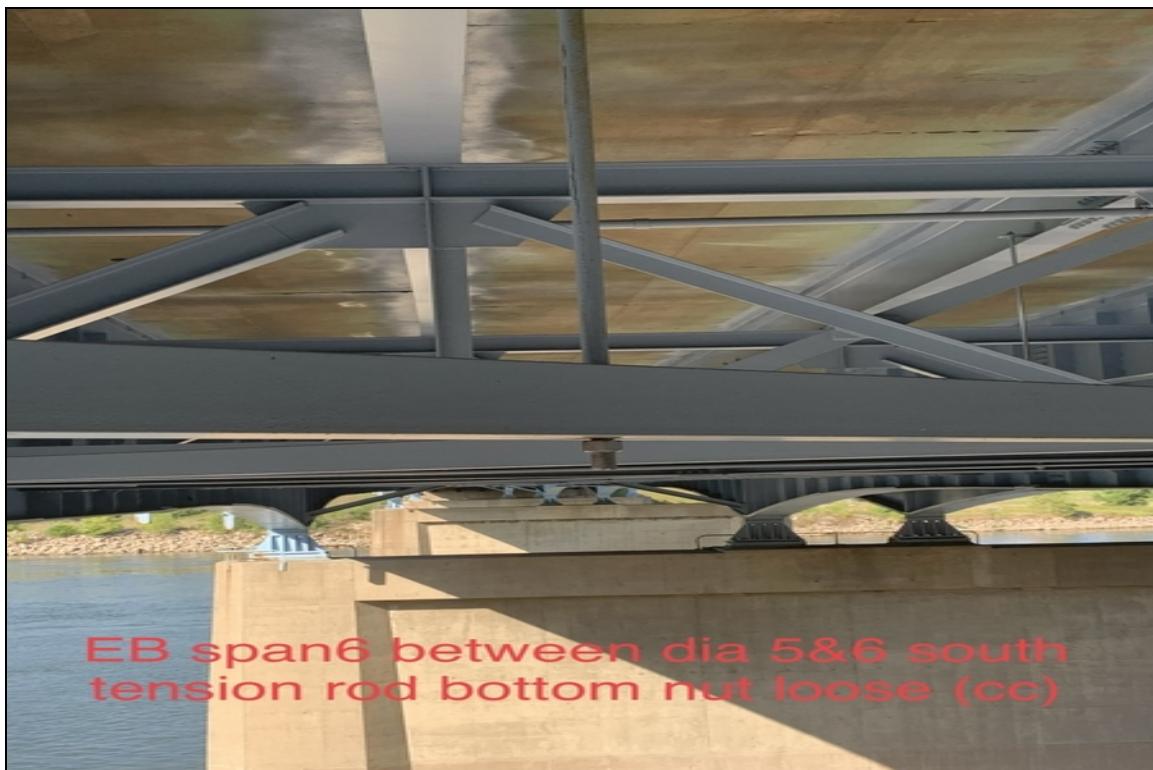
EB span 6 between dia 5&6 south tension rod bottom nut loose looking west (cc)

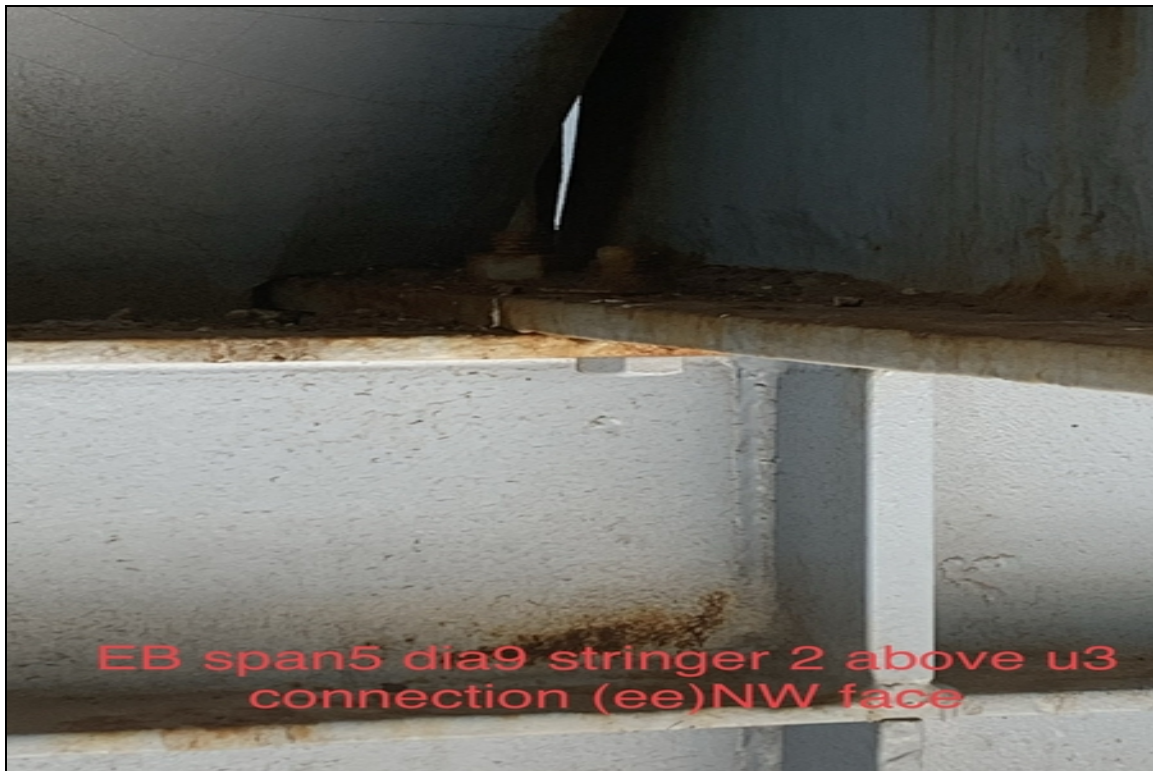
EB span 5 dia 9 stringer 2 above U3 connection (ee) NW face

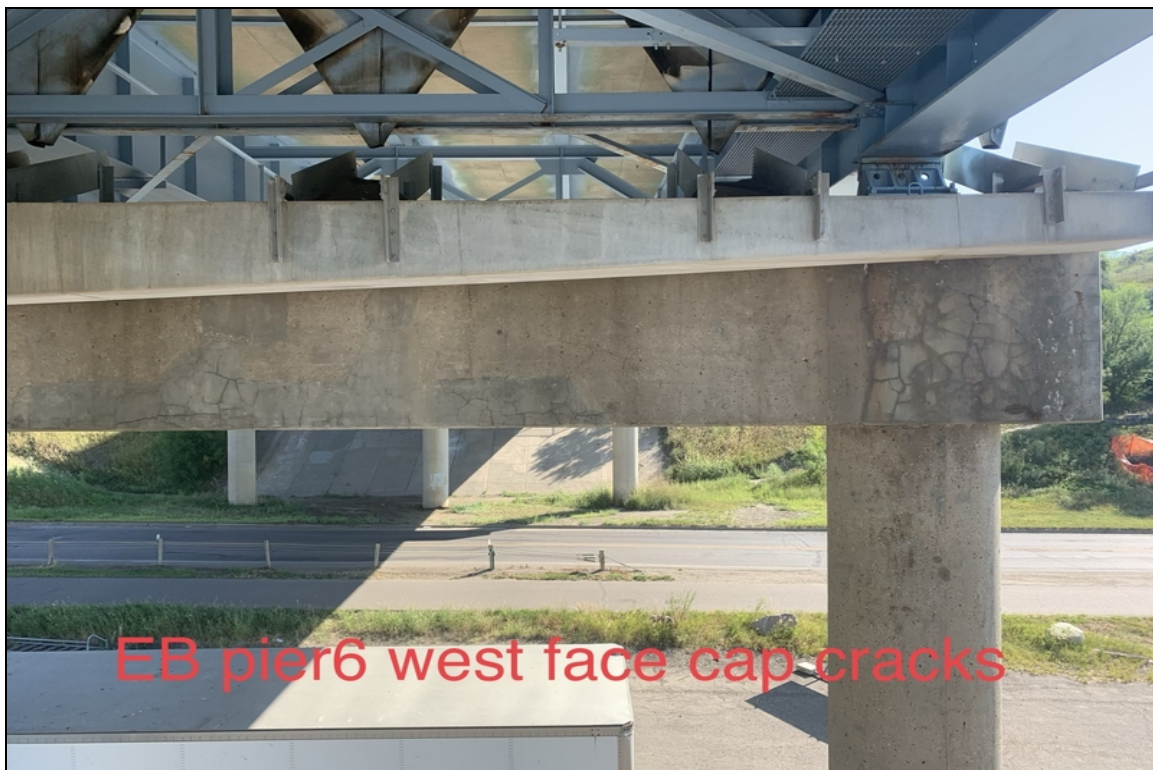
EB pier 6 west face cap cracks

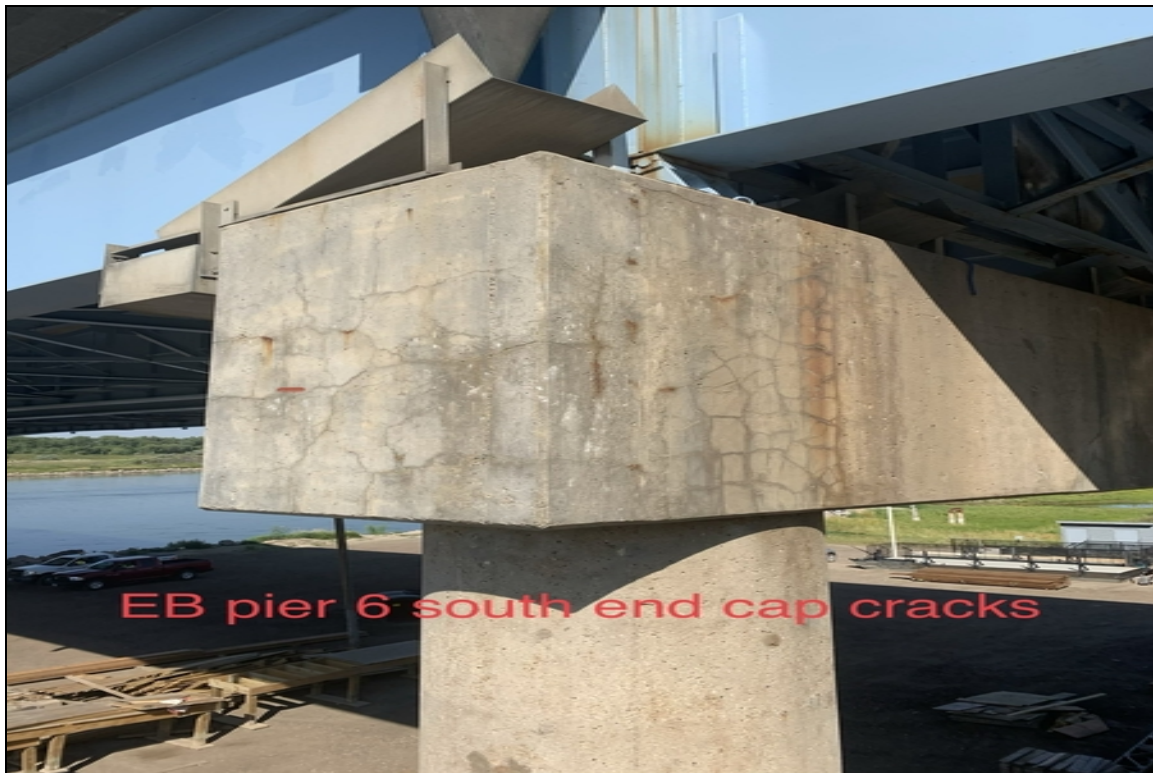
EB pier 6 south end cap cracks

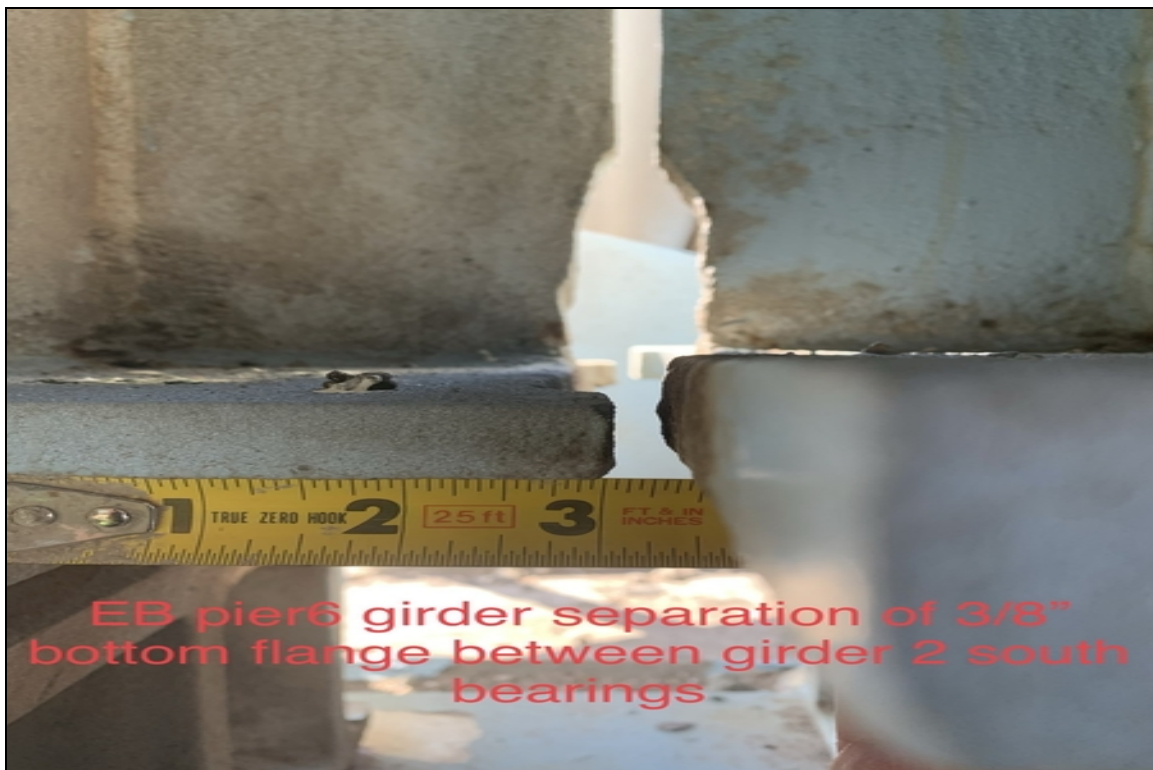
EB pier 6 girder separation of 3/8" bottom flange between girder 2 south bearings north face

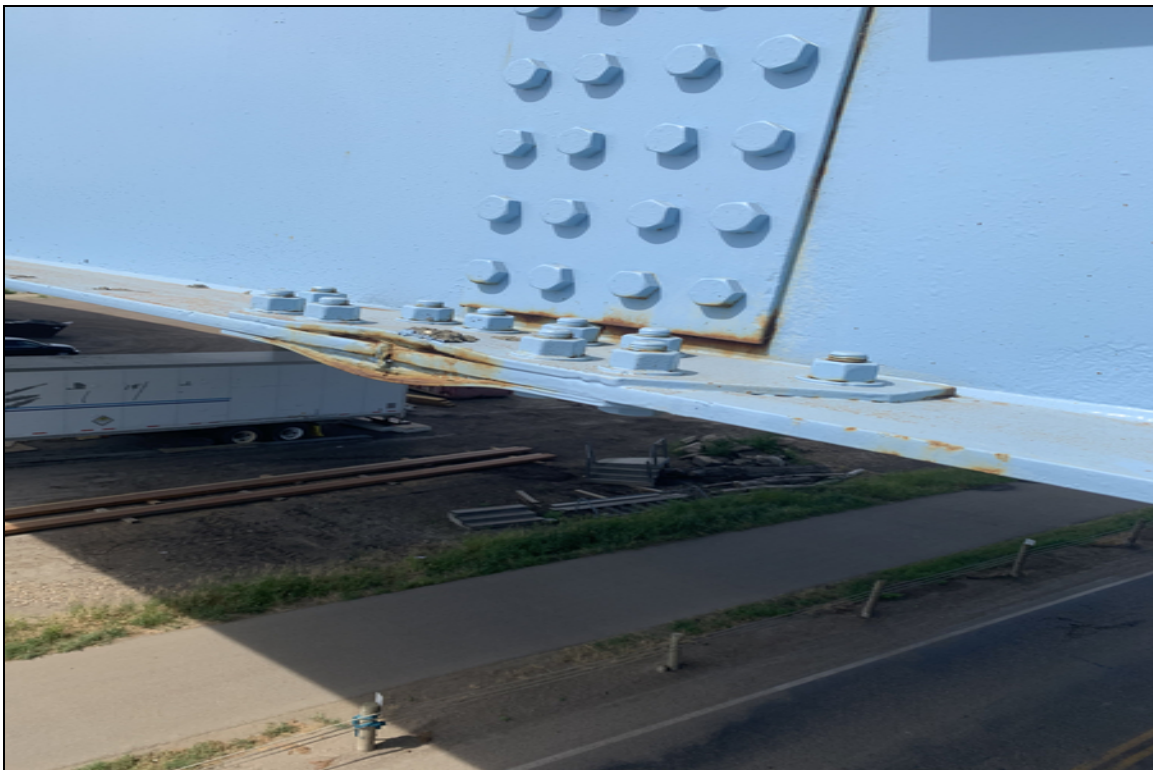
EB span 6 girder 2 splice plate rust bulging south face

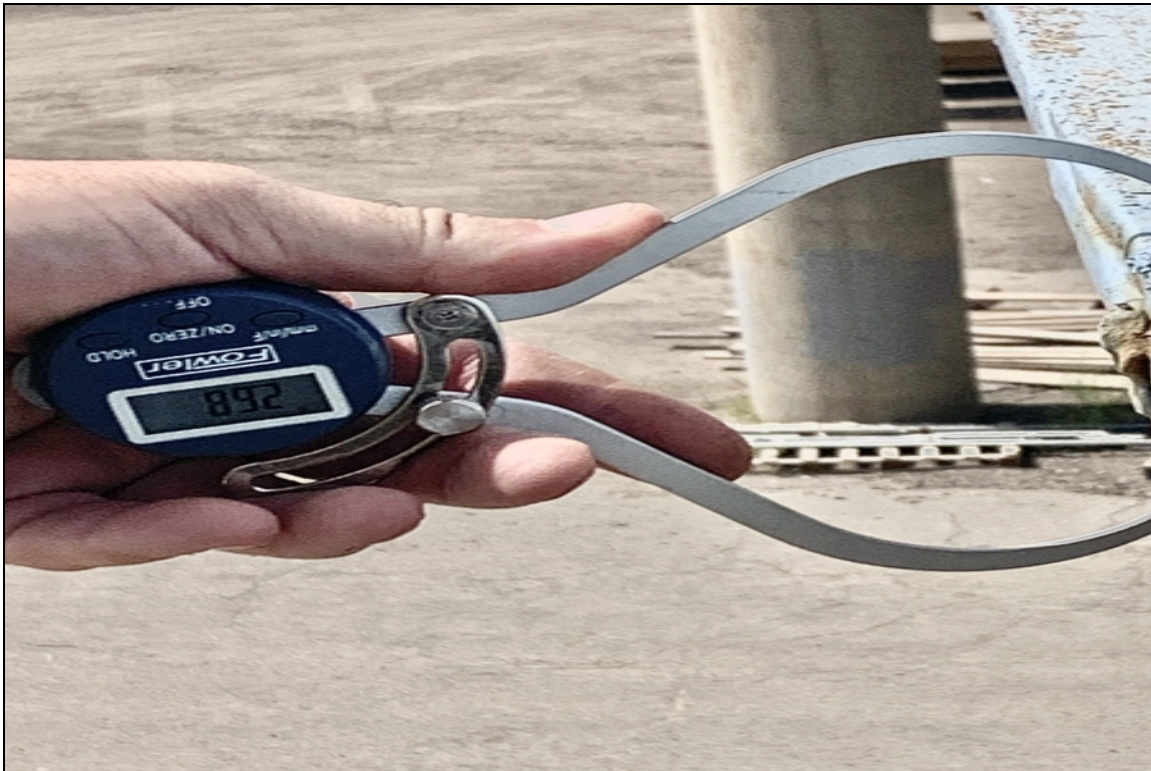
EB span 6 girder 2 splice plate 2.68" thick original thickness is measure 1.43"

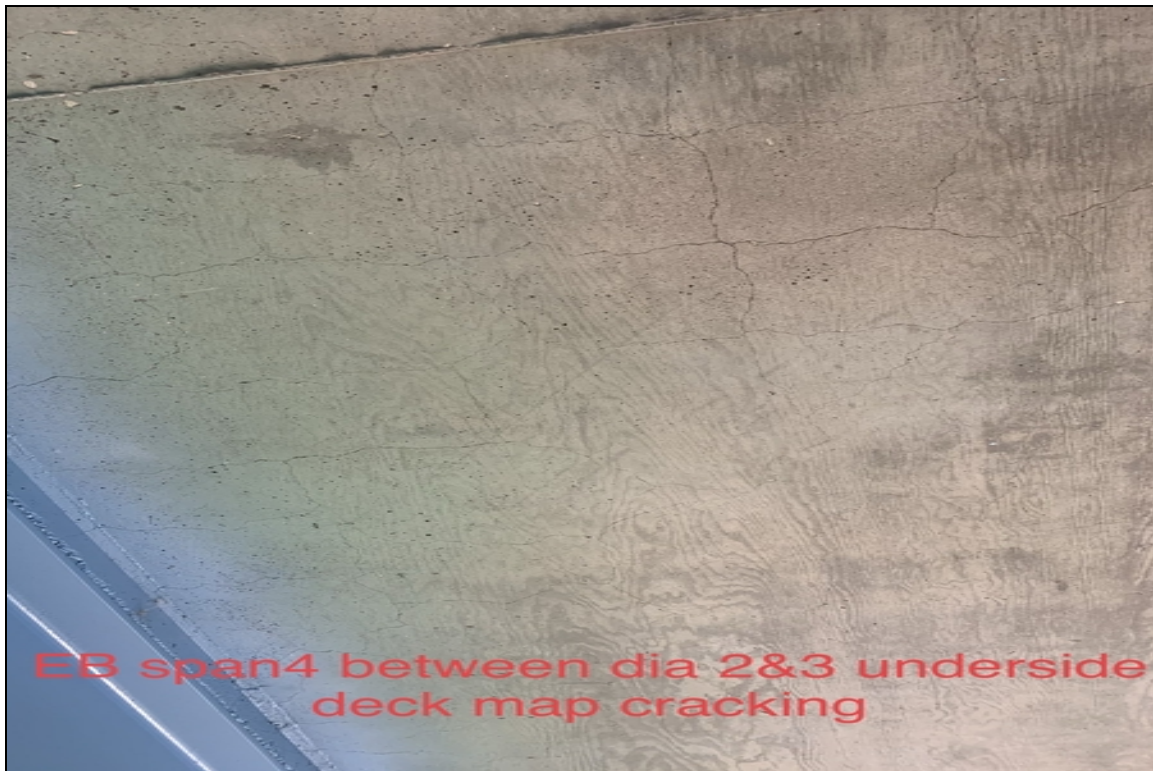
EB span 4 between dia 2&3 underside deck map cracking

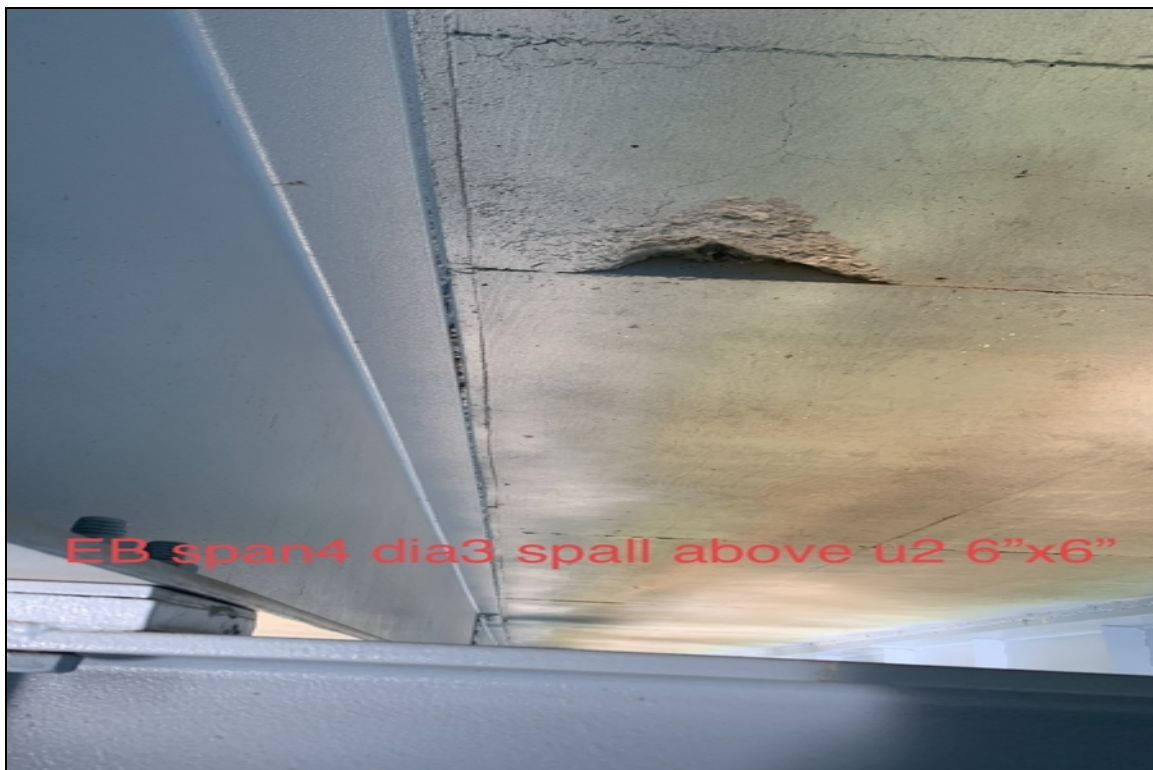
EB span4 dia 3 Spall above u2 6"x6"

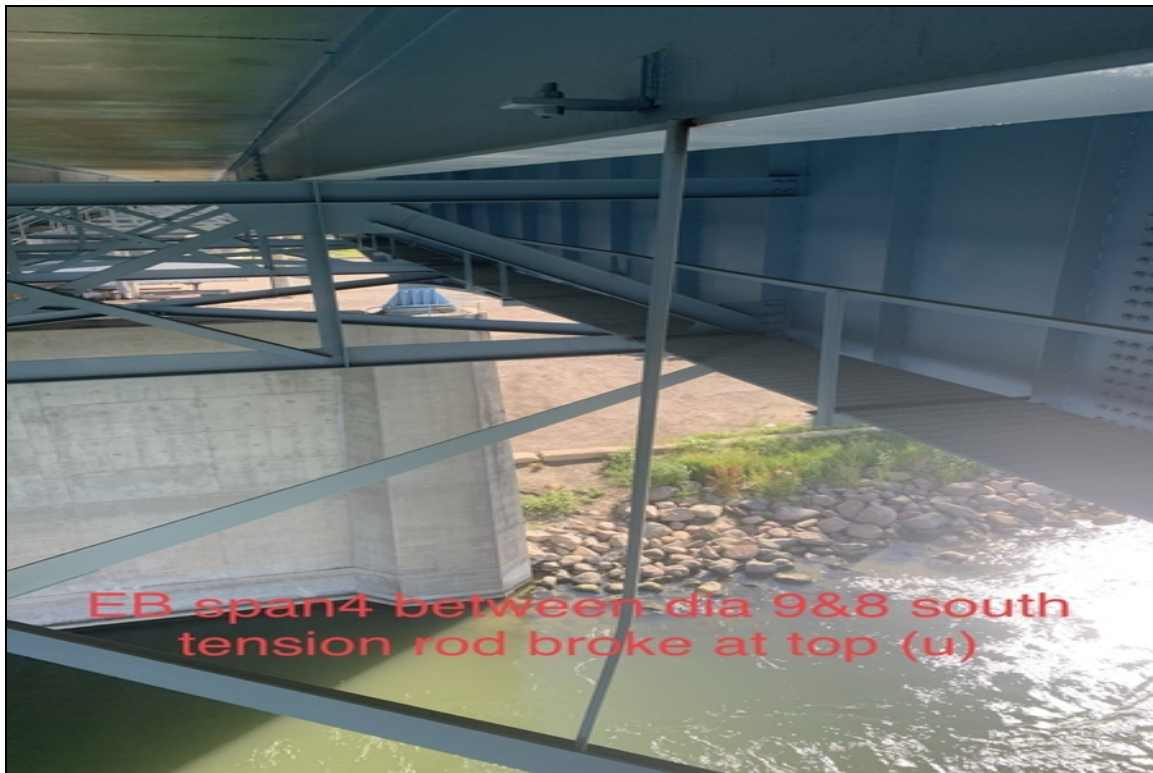
EB span 4 between dia 9&8 south tension rod broke at top west face (U)

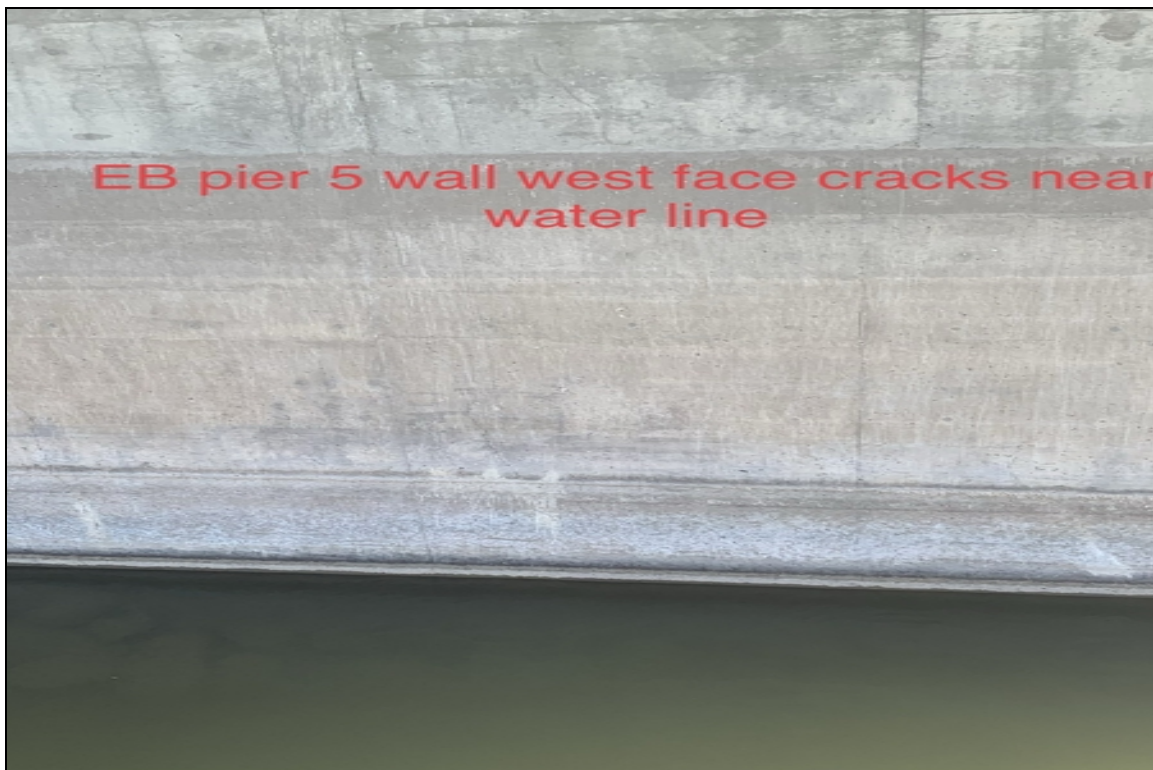
EB pier 5 wall west face cracks near water line

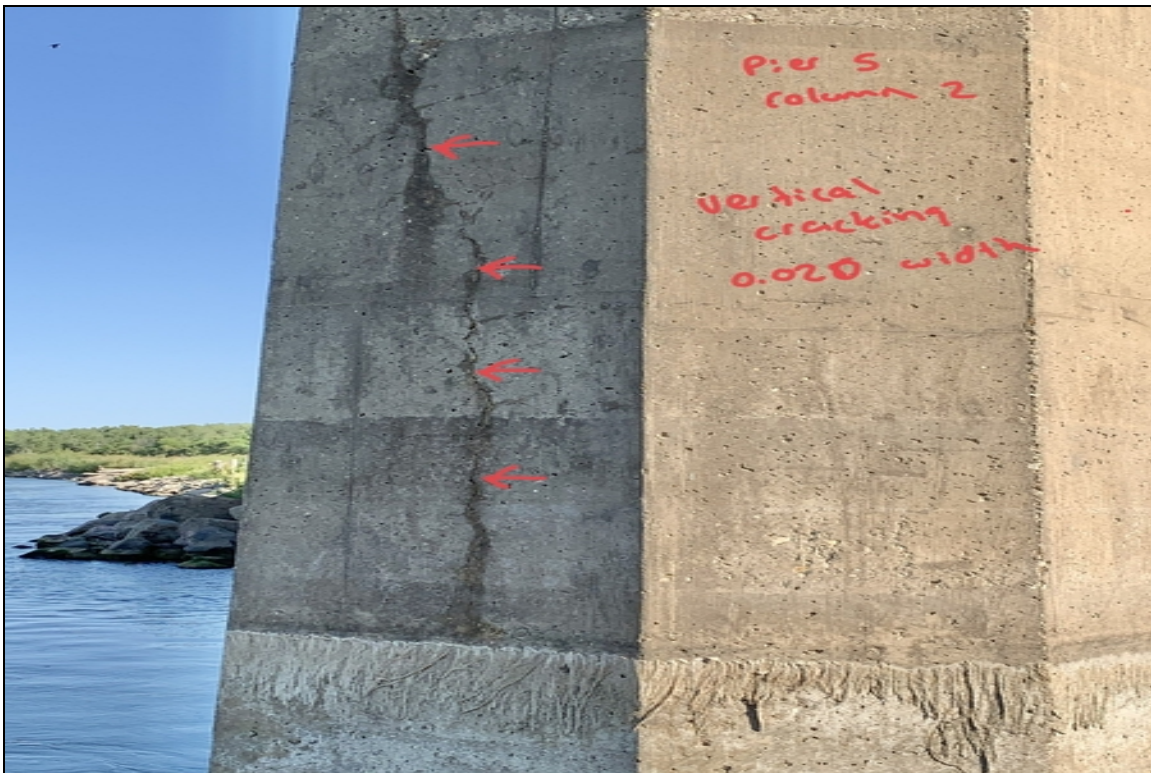
Facing North. Vertical Cracking to Pier 5 South Column.
